01 Current Insulated Bearings

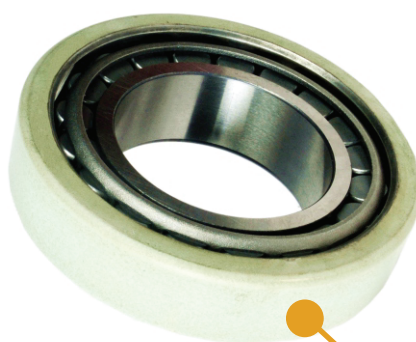
The image below is a microphoto of damage resulting from electrical discharges

When a stray current in an electric motor uses a bearing as its path to ground, bearing damage can occur. The **electric current passing can cause micro cratering** in the raceways of inner & outer rings and on the rolling element surface which ultimately changes the . structure of the metal

Once bearing damage from **electric corrosion** has begun, increased noise levels, reduced effectiveness of lubricant and excessive vibration will **drastically decrease** . bearing service life

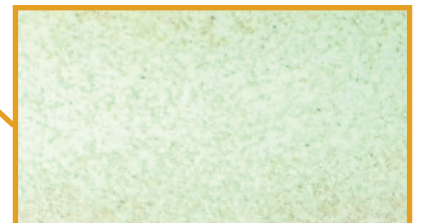
"INSUCOAT"

To overcome this problem UST engineers have developed in collaboration with a university a **special ceramic coating which ensures 100% protection and electric insulation**. The coating is applied using a "plasma spraying technology" from Europe

The coating can be applied on the inner or outer ring depending . upon the application

The insulation has a guaranteed breakdown resistance for at least 1000V in standard. For higher resistance as well R&D team has developed a special coating to ensure insulation upto 3000V
